Optima / Sorento / Sportage Sunroof Glass Status

Kia Motors America 05/31/2013

Panorama Sunroof Glass Summary

XM Panorama Glass Investigation

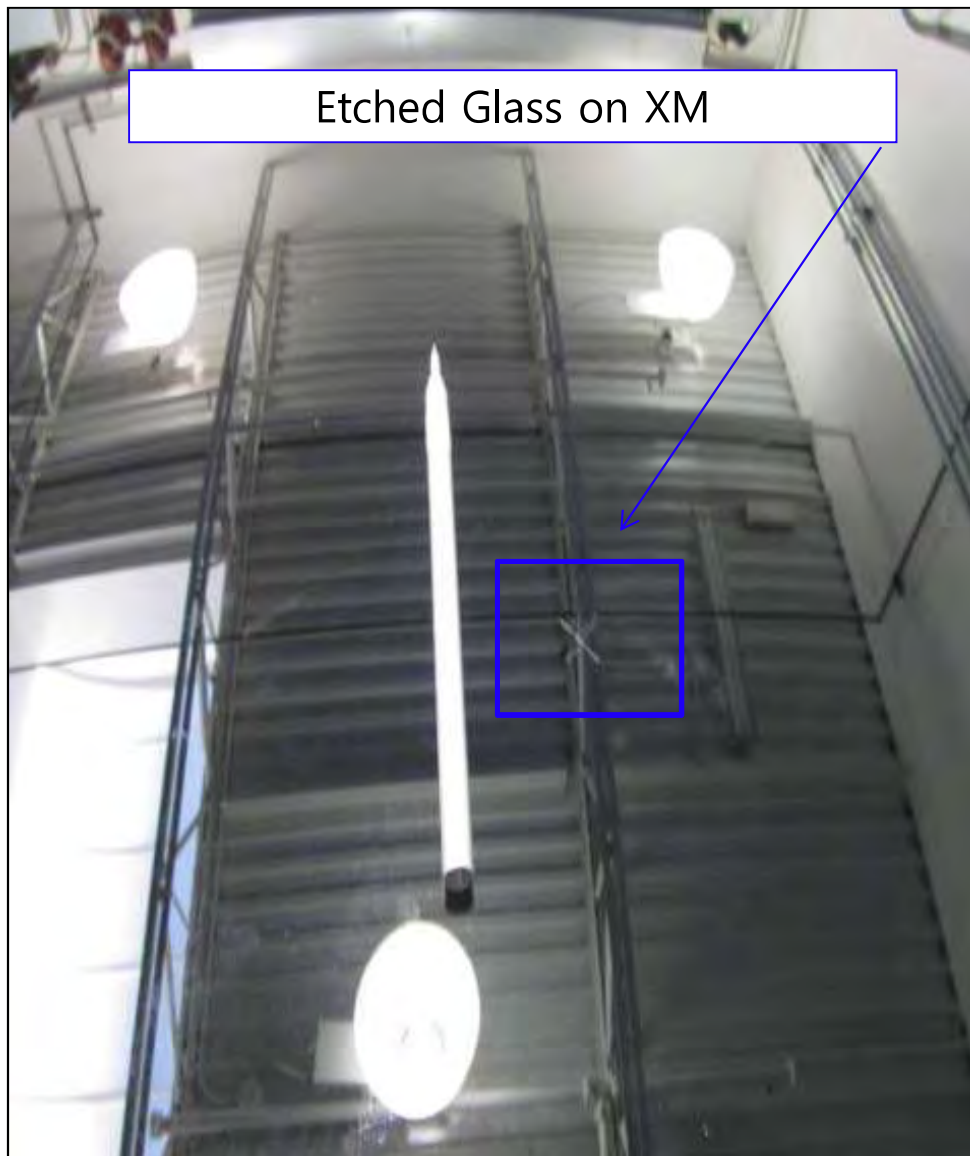
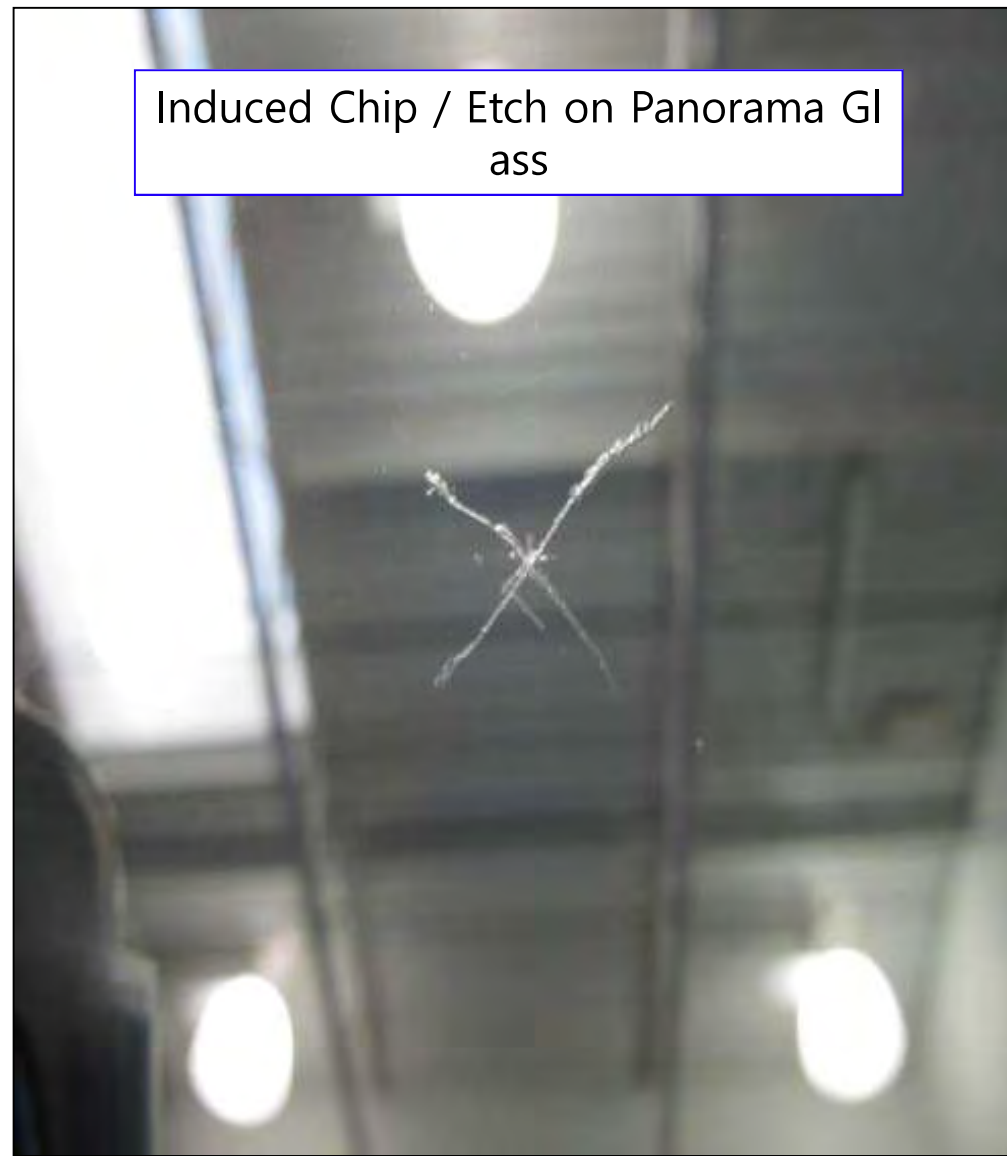
Panorama Glass Induced Chip

1. Hardened/Tempered glass spontaneously shatters for two main reasons:
 - a) Impact at edge into the body of the glass.
 - b) Impurity in the glass (e.g. metal flake) leading to different expansion rates and high localized stresses.
2. Hardened glass has residual compressive stress on exterior surfaces, this causes any surface scratches to be negligible.
3. The most damaging effect on hardened glass is a crack that penetrates to the tensile inner "body" of the glass.
4. The largest stress on the glass surface is at the edges.
5. The center of a large sheet of glass can absorb a very large impact, and shock, and shattering here is not likely.

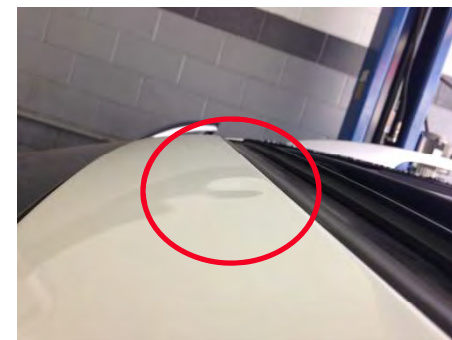
- ❖ Large dent which should have required some force found on left side of roof very close to leading edge of glass was most likely the impact which caused glass to shatter

Glass Shattered, Shade Forced Back

Large Dent Near on Roof Near Glass

- ❖ Vehicle currently part of a CA case and Pano Roof assy is not be removed but preserved in place for evidence
- ❖ Pano Roof glass shattering does not appear to be due to any material defect but rather it was due to impact with road debris and thus it is not going to be valuable for further investigation by the supplier or KMMG

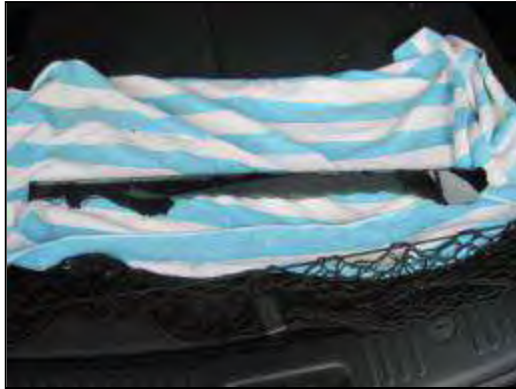
(a) Front Bracket

- Pictures directly above show how the glass did stay adhered to brackets showing no signs of e-coat separation and fragmented as tempered glass should.
- All brackets were shipped back to Webasto facility in MI for additional testing to verify no concerns.

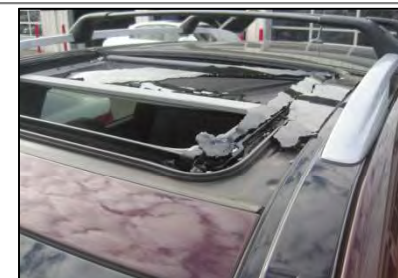
- During evaluation there was no visible damage to the roof.
- After initial analysis of glass fragments, tempering of glass appears to be within specification.

- **After glass analysis by Webasto, KMMG and KMA, it was difficult to determine the root cause of the pano roof failure. Much of the glass on the leading edge of the sunroof was blown away as customer was on highway when fracture occurred and drove vehicle in for service as well. There were no witness markings present that would indicate unit was damaged by external cause. All brackets were secure and pano roof appeared to be operating as designed. Dealer replaced the glass under warranty as no definite cause was identified.**
